A STUDY OF AGING EFFECT ON RUBBER BEARINGS AFTER ABOUT TWENTY YEARS IN USE

ABSTRACT

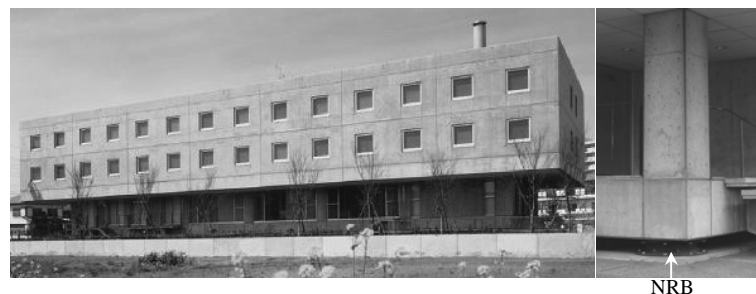
Figure 1 Appearance of the building

The building is a three-story dormitory for employees of Takenaka Corporation located about 25 km east of the center of Tokyo, which was completed in 1987. The structure is composed of RC moment frames and shear walls. Exterior views of the building are shown in Figure 1.

Figure 2 shows that 14 natural rubber bearings and eight viscous dampers are applied in the building. Since the rubber bearings are placed above the ground level as seen in Figure 1 and Figure 2, these bearings are exposed to damaging factors such as direct sunlight, oxygen and rainwater. Such a severe environmental condition will affect the mechanical and chemical characteristics of the bearings more than those of general bearings. Therefore, the results of this study provide a critical evaluation for aging effect of rubber bearings.

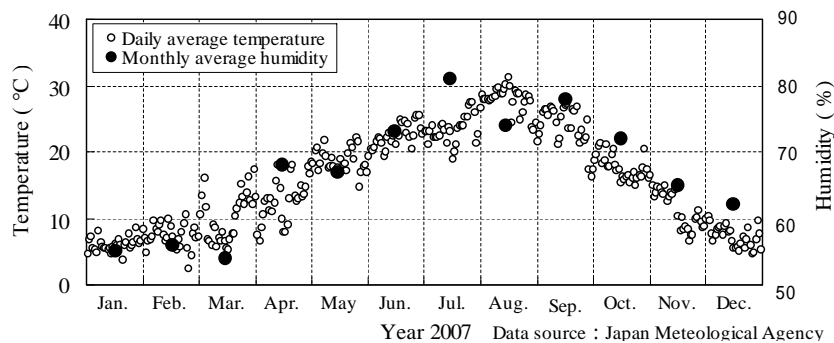
Figure 3 Fluctuation in temperature and humidity near the site (2007)

Fluctuation in temperature and humidity near the building site for the year of 2007 is shown in Figure 3. Changes in temperature and humidity are supposed to have been calm these 22 years because the building has been sited in a quiet residential area.

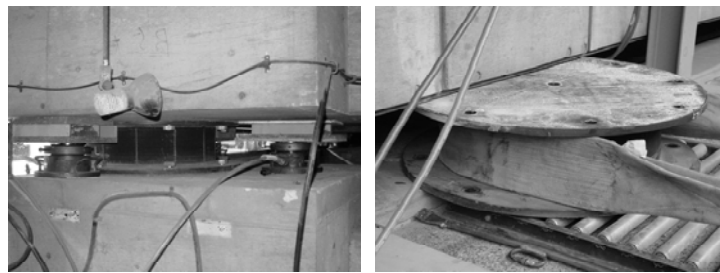
Figure 4 The view of replacing a rubber bearing (2008)

The rubber bearings were manufactured by Bridgestone Corporation in Aug. 1986. As shown in Figure 2, one bearing was taken out from the building and replaced with a new one in May 1996 and another one was done in May 2008, respectively. Figure 4 shows a view of replacing a rubber bearing in 2008. The superstructure was partly pushed up by nine oil jacks with capacity of 1,000 kN. The size of the rubber bearing is shown in Figure 5, while the design specifications are shown in Table 1.

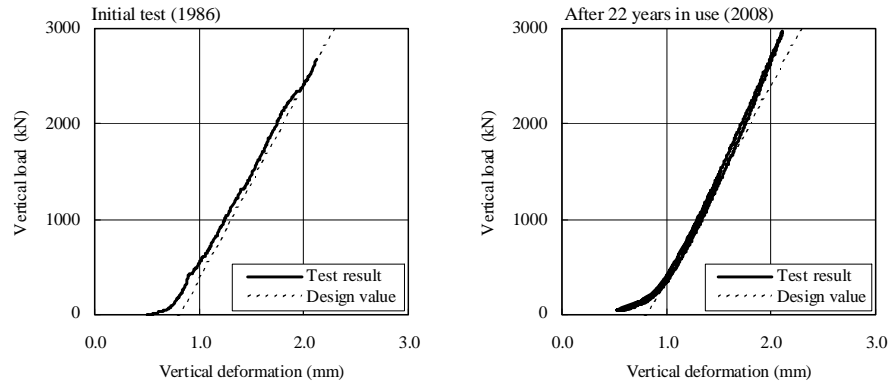
Figure 7 Comparison of vertical hysteresis loops

Values of vertical stiffness are summarized in Table 4, while the design value is 2019 kN/mm . Hysteresis loops from the initial test and from the test after 22 years in use are shown in Figure 7. Figure 8 shows the change of ratio in vertical stiffness to the initial values. Vertical stiffness after 10 and 22 years in use increased about 16 to 19 % and 13 to 15 % compared to the initial values, respectively. One of the reasons why the change in 10 years is larger than the change in 22 years should be a variation in the initial values between the two rubber bearings. A certain accelerated aging test reports that vertical stiffness increases 7 to 17 % in 40 years (The Society of Rubber Industry of Japan, 2000). Approximately, the test result in this study has a similar tendency to the accelerated aging test.

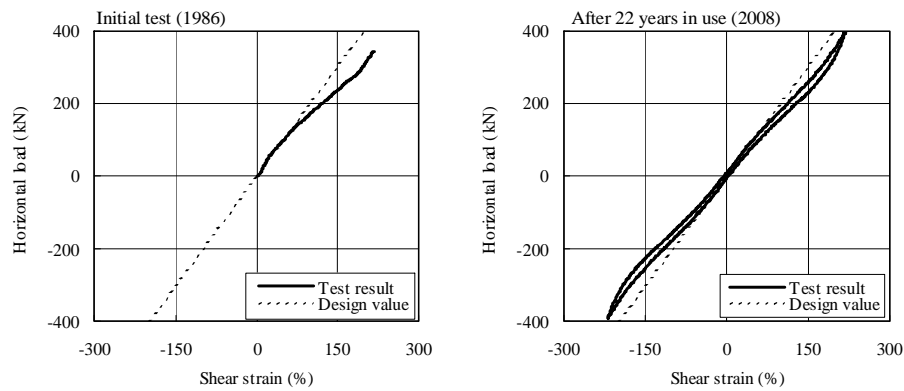
Figure 9 Comparison of horizontal hysteresis loops

Hysteresis loops of the third loading at the initial test and the test after 22 years in use are shown in Figure 9. In the hysteresis after 22 years in use, hardening property appeared more clearly at around shear strain of 200 %.

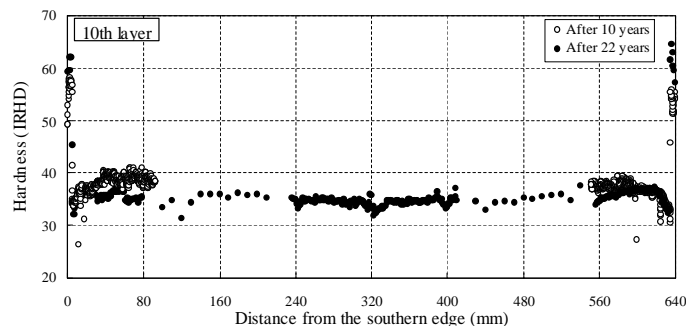
Figure 12 Hardness of rubber material after 10 and 22 years

Since no clear difference among the results of three layers was observed, IRHD for the tenth layer is representatively shown in Figure 12. Except for the covering EPDM, having larger hardness, Figure 12 shows that hardness distribution is almost uniform both after 10 and 22 years in use. Also the Figure indicates that there is no apparent difference in hardness between the rubber after 10 and 22 years in use. In general, rubber becomes harder by being oxidized for years. Oxygen in the air attacks the surface rubber first and it penetrates inside gradually. This causes an apparent change in hardness distribution such as the rubber of Pelham Bridge shown in Figure 13. These test results draw an inference that a rubber bearing is hardly damaged by oxygen in the air, when being covered by synthetic rubber.

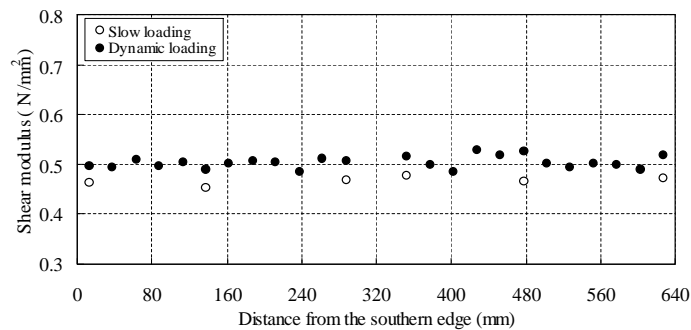
Figure 17 Shear modulus of rubber material after 22 years

Shear moduli of the rubber material after 22 years in use are shown in Figure 17. There is no apparent difference in the value between the distances from the edge. This test result also draws the inference that a natural rubber bearing is hardly damaged by oxygen in the air, when the bearing is covered by synthetic rubber such as EPDM. Comparisons between the test results of the two rubber materials after 10 and 22 years in use are shown in Table 6. Values in the table give averages of all test results. Noticeable aging effect cannot be found from these test results.
